Memorandum

Subject: Pre-CERCLIS Screening Assessment of Doris Mine, McKinley
County, New Mexico: Further action under CERCLA
Recommended

Site name	Doris Mine			
City	not applicable	State	New Mexico	Zip code not applicable
County	McKinley			
Latitude	35° 20' 20.24"	Longitude	107° 47' 48.34"

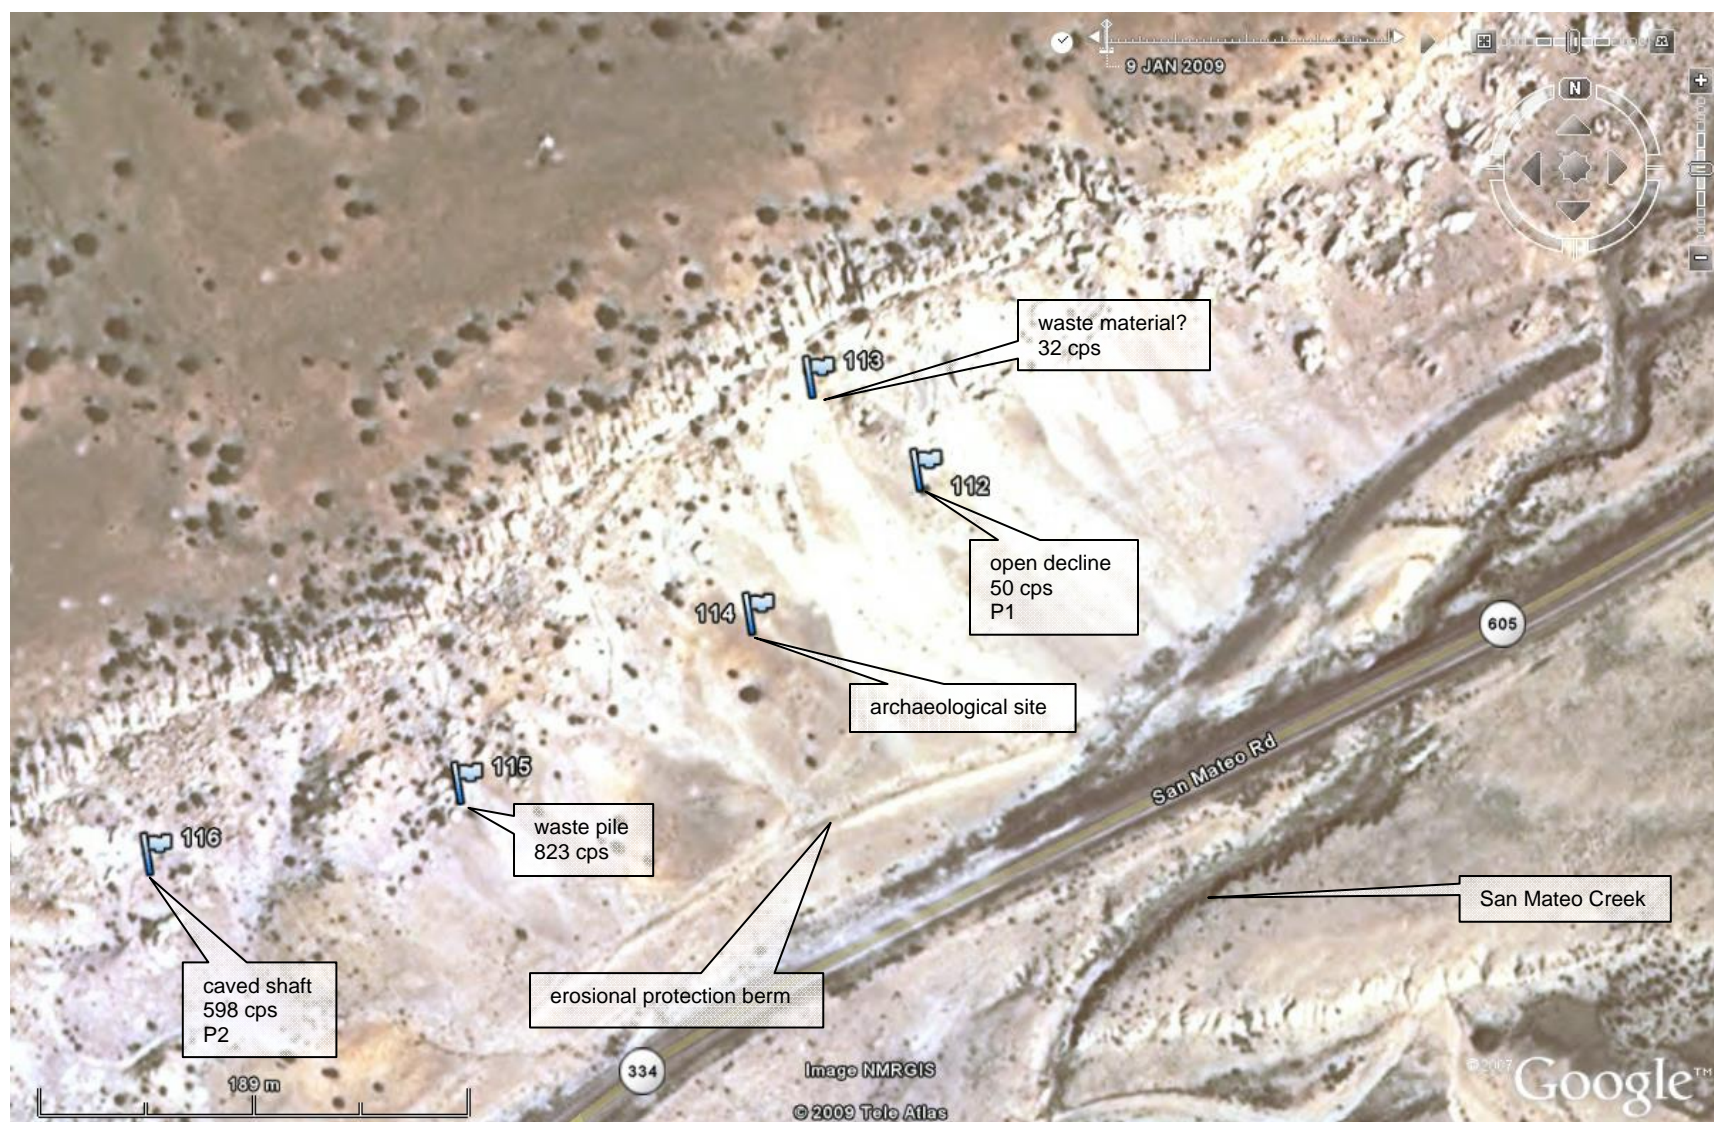
Figure 1: Doris Mine

Site summary: Observations made during NMED's Site reconnaissance are shown on

"Px" reference the location of photographs on pages following.

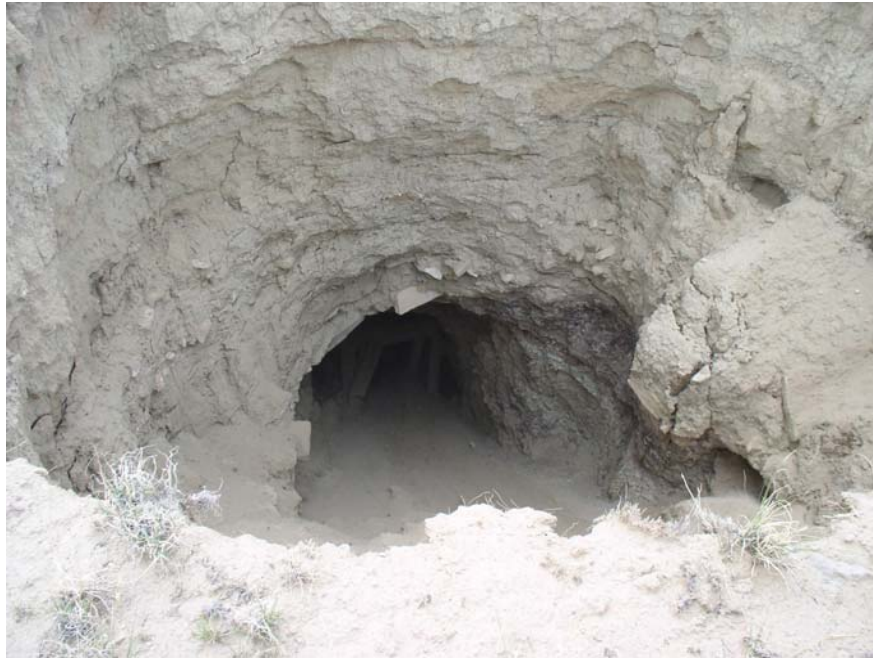
the accompanying figures. The open decline shows recent evidence of subsidence, and is poorly protected from public access by a fence that will collapse as the crater containing the decline continues to enlarge. The highest radioactivity reading was measured at a waste rock pile (823 counts per second [cps]; background=32 cps). Contamination may be dispersed via precipitative erosion and wind, or may impact ground water via seepage through alluvium or through the open shaft and decline. The open decline is easily accessible from the paved road.

P1: Doris mine open decline

1. Remove waste with elevated radioactivity.
2. Plug open decline and shaft.

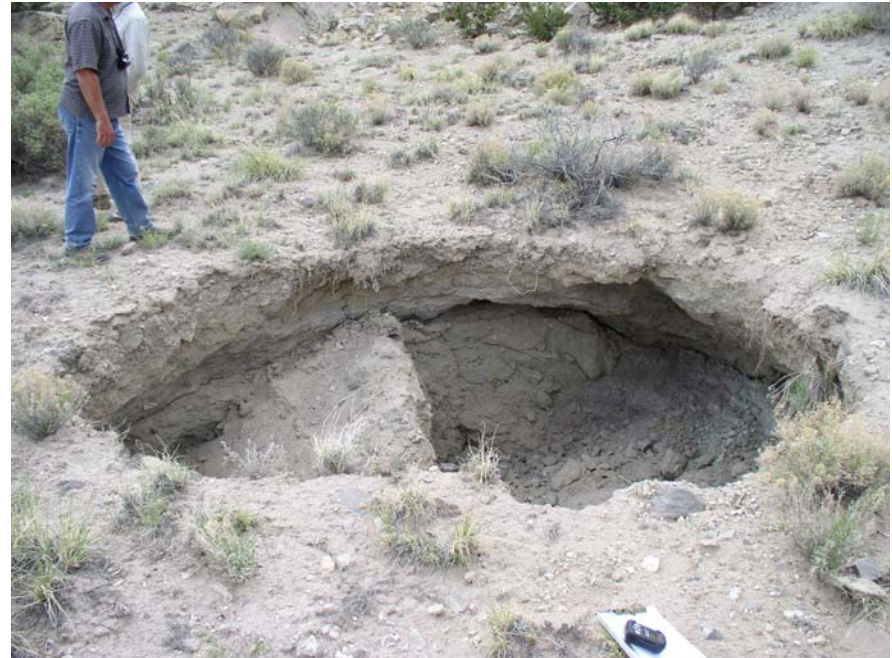
Site physical description: The Doris Mine is easily accessible from State Highway 605, and is located within 0.25 miles of San Mateo Creek. The site currently has a fenced open decline within a collapsing subsidence crater and a second unfenced and caved shaft approximately 0.25 miles south of the decline. Several waste material piles are scattered around the site. An archaeological site, marked by piles of rock and pottery shards, is located in the middle of the minesite. An erosional protection berm has been constructed parallel to the highway along most of the site perimeter.

P2: Doris mine caved shaft
